Building Work Rectification Order

Section 33 of the Residential Apartment Buildings (Compliance and Enforcement Powers) Act 2020

Bennett Hilly Development Pty Ltd (ACN 165 271 303) is being given this Building Work Rectification Order (Order) in relation to addresses 1 Northcote Street (SP 95581), MORTLAKE NSW 2137 and 14-22 Hilly Street (SP 95582), MORTLAKE NSW 2137 (the Development).

5. **Bennett Hilly Development Pty Ltd (ACN 165 271 303)** is the developer of the residential apartment building known as ‘**Majors Bay Residential Development**’ 1 Northcote Street Mortlake NSW 2137 (SP 95581) and 14-22 Hilly Street Mortlake NSW 2137 (SP 95582) (**the Development**) for the purposes of section 4(a) of the Act.

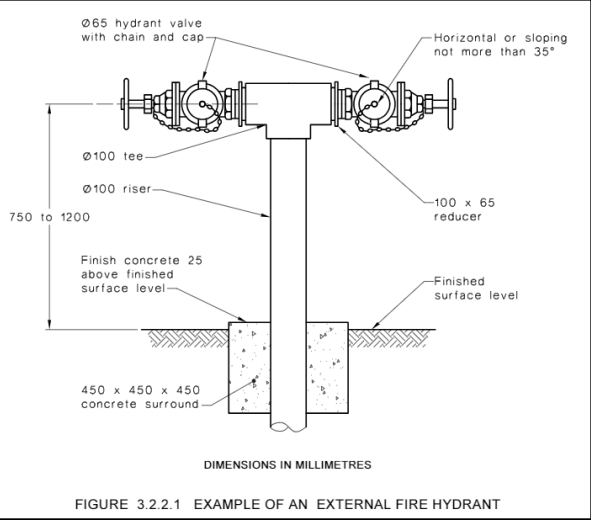
Serious Defect Ref No.	Building element in which serious defect has been identified	Defect	Reason why defect is a serious defect	Applicable approved plan, Code or Australian Standard	Consequences of serious defect
1.	Fire safety system	Fire hydrant not installed at required height	Fire hydrants must be easily accessible to fires services during case of fire	The installation of the fire hydrant at the incorrect height demonstrates a failure to comply with Australian Standard 2419.1 2005 Fire Hydrant Installations Part 1: System design, installation and commissioning. Section 3 Locations and Other Provisions, Clause 3.2 Location of On-Site Fire Hydrants, Clause 3.2.2.1 which refers to Figure 3.2.2.1 states:	During a fire, the improper height may delay or impede fire brigade activities.

<p><i>“The centre line of the fire hydrant valve or outlet not less than 750mm and not more than 1200mm above the ground, finished floor level or platform.”</i></p>

1.	Fire stair – basement level 3	The fire hydrant has been installed below the minimum required height. Installation is at 725mm.	<p>The Developer is to take the following steps to rectify the serious defect to comply with Australian Standard 2419.1 2005 Fire Hydrant Installations Part 1: System design, installation and commissioning:</p> <ol style="list-style-type: none"> 1. Rectify the hydrant valve installation to ensure the height of the centre line is not less than 750 mm and not more than 1200 mm above the ground. 2. Rectify any consequential damage. 3. Developer to demonstrate compliance of remediation works by providing evidence to ocaudits@customerservice.nsw.gov.au of comprehensive photographs of work in progress, installer compliance certificates and any third-party inspection reports provided by a fire safety consultant. 	2 weeks

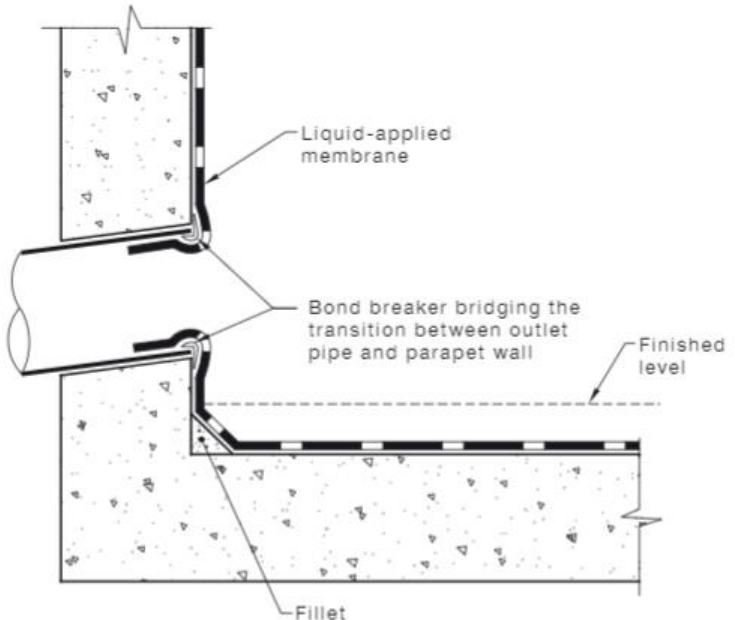
6.	Waterproofing	Waterproofing membrane has not been turned into overflows	Waterproofing must be turned into the overflow to prevent water tracking behind the membrane	<p>The inadequate waterproofing demonstrates a failure to comply with the BCA 2014 Volume One, Section F Health and Amenity, Part F1 Damp and weatherproofing and the following performance requirements, FP1.4 Weatherproofing, which states:</p> <p><i>“FP1.4 A roof and external wall (including openings around windows and doors) must prevent the penetration of water that could cause –</i></p> <p><i>(a) Unhealthy or dangerous conditions, or loss of amenity for occupants; and</i></p> <p><i>(b) Undue dampness or deterioration of building elements.”</i></p>	Water could penetrate behind the membrane, causing degradation of building elements

<p>And</p> <p>The Australian Standard 4654.2 2012 Waterproofing Membranes for external above-ground use, Part 2: Design and installation – Section 2 Design and Installation, 2.11 Overflows which states:</p> <p><i>“2.11 Overflows</i></p> <p><i>The membrane shall be turned into the overflow, to prevent moisture from tracking behind the membrane.</i></p> <p><i>The finished floor level shall not reduce the design flow of an outlet.</i></p> <p>NOTES:</p> <p><i>1. Typical examples of membranes turned into the overflow are shown in Figure 2.16.</i></p> <p><i>2. Overflow facilities should direct water away from the building.”</i></p>	
--	--	--	--	---	--
