Gasfitting Industry Advisory Note 1/2013

To: Licensees / Contractors working in the Gasfitting industry From: Energy Utilities Unit, Home Building Service, Parramatta

Date: 16/08/2013

Subject: The use of Composite type pipes on Gas installations

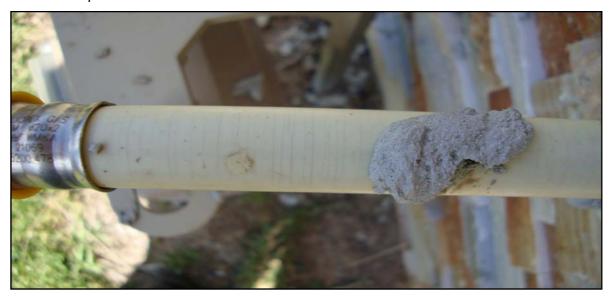
Currently, composite pipe may be used in a gas installation, including where there is a connection to a gas meter. Where the service passes through a wall, and/or when exposed to sunlight, the composite pipe has been known to fail, including cracking of the outer skin of the pipe.

Composite Pipe Failure - This section of pipe shows evidence of breaking down Image:

with cracks appearing on composite pipework exposed to direct sunlight

Fair Trading has become aware of this pipe failure as described and is recommending that where any part of a gas installation is exposed, then consideration should be given in the use of an alternative pipe material. Continued use of composite pipe requires UV and mechanical protection.
