Building Work Rectification Order

Section 33 of the Residential Apartment Buildings (Compliance and Enforcement Powers) Act 2020

Briens Rd Developments Pty Ltd (ACN 640 206 104) is being given this Building Work Rectification Order (Order) in relation to address 34-36 Briens Road, Northmead NSW 2152 (Lot 1 & B, DP 15342 & 320582) (the Development).

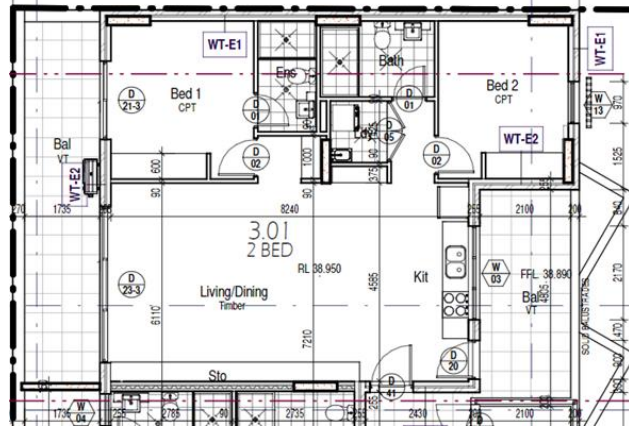
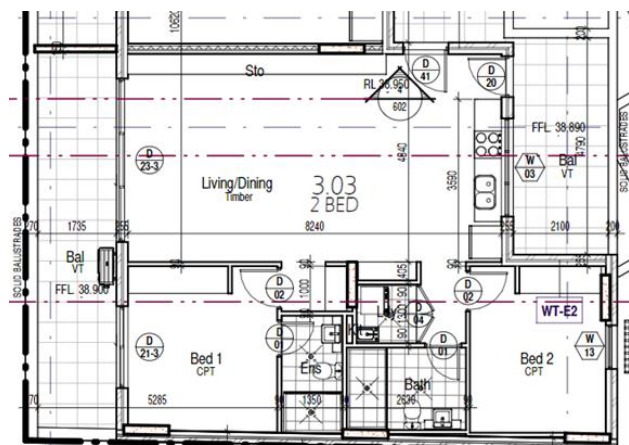
3.	Building enclosure	A door to the balcony has not been installed consistent with the approved plans	The approved plans provide for a door located in the kitchen. This has not been installed	Architectural Plans issue for construction issue 1, Drawing 315 shows a door marked (D20) located on the left side of the window (W03) to the kitchen wall. Drawing 801, Door schedule indicates D20.	Residents cannot access the balcony from within the unit and must go outside to access the balcony

<p>Architectural Plans issue for construction issue 1, Drawing 315 shows a door (D20) located on the right side of the window (W03) to the kitchen wall.</p>

3.	Level 3 Units 301 and 303	A door to the balcony has not been installed consistent with the approved plans	<p>The Developer is to ensure the following building work is carried out:</p> <ol style="list-style-type: none"> 1. The door included on the approved plans is installed. <p>Alternatively:</p> <p>The Developer is to take the following specified action:</p> <ol style="list-style-type: none"> 1. Ensure the building practitioner obtains a regulated design and design compliance declaration for the building element prepared by a registered design practitioner. 2. Ensure the building practitioner or appropriate practitioner to lodge the regulated design and design compliance declaration on the NSW Planning Portal in the approved way prior to commencing building work. <p>The Developer is to ensure the following building work is carried out:</p> <ol style="list-style-type: none"> 1. Install doors to balcony as provided for in approved plans and in accordance with the regulated design. 2. Rectify any consequential damage. 	2 months

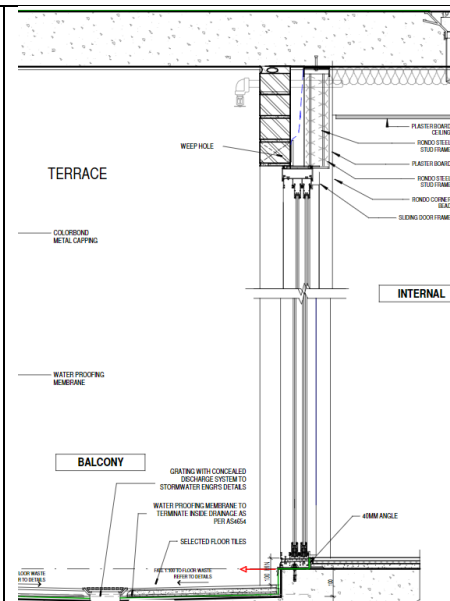
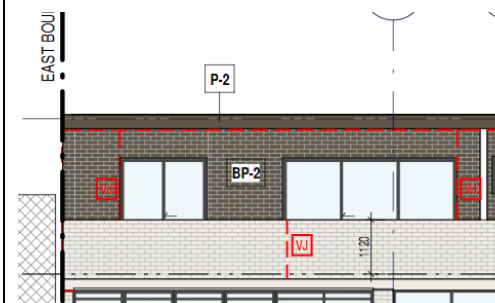
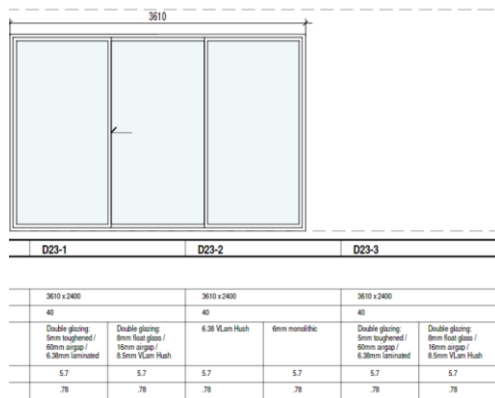
5.	Building enclosure	Sliding doors installed measure 2880mm in height	The approved plans show sliding doors at 2400mm height with brickwork above the window head.	The failure to install the appropriate sliding doors demonstrates a failure to comply with the approved plans Elevation Drawing titled “DETAIL SECTIONS” ref 570 dated 15/12/202 rev 2 by ZHINAR Architect which provides:	Construction not in accordance with the approved plans could lead to water ingress, reduced thermal performance of the facade and reduced acoustic

<p>And drawing titled “ELEVATIONS” ref 500 dated 15/12/21 rev 2 by ZHINAR Architect which provides:</p> <p>And approved plan titled “DOOR SCHEDULE” ref 801 dated</p>	<p>performance of the façade</p>
--	--	--	--	---	----------------------------------

And drawing titled "ELEVATIONS"
ref 500 dated 15/12/21 rev 2 by
ZHINAR Architect which provides:

And approved plan titled "DOOR
SCHEDULE" ref 801 dated

5.	All balcony sliding doors	Sliding doors installed measure 2880mm in height. The approved plans show sliding doors at 2400mm height with brickwork above the window head.	<p>The Developer is to ensure the following building work is carried out:</p> <ol style="list-style-type: none"> 1. The balcony door construction is in accordance with the approved plans, including a door height of 2400mm with brickwork above the window hand. <p>Alternatively:</p> <p>The Developer is to take the following specified action:</p> <ol style="list-style-type: none"> 1. Ensure the building practitioner obtains a variation to the regulated design and design compliance declaration for the building element prepared by a registered design practitioner. 2. Ensure the building practitioner or appropriate practitioner to lodge the regulated design and design compliance declaration on the NSW Planning Portal in the approved way prior to commencing building work. <p>The Developer is to ensure the following building work is carried out:</p> <ol style="list-style-type: none"> 1. Install the door per the approved plans and in accordance with the regulated design. 2. Rectify any consequential damage. 	3 months

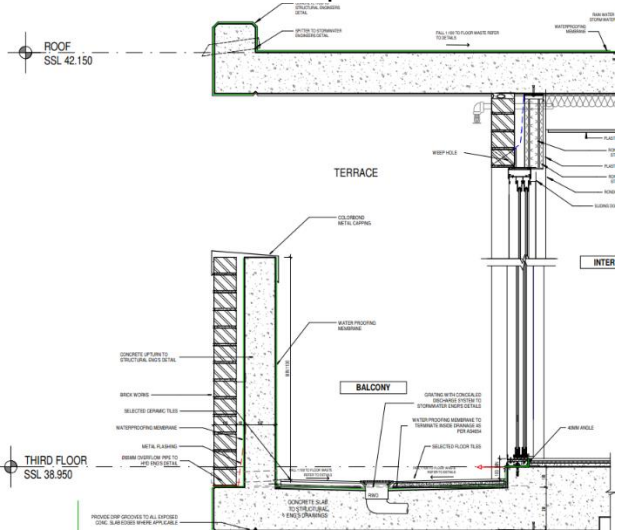
8.	Building enclosure	Brick capping has been installed on top of balustrade walls	The approved plans provide for metal capping. Brick is a porous material that may allow water entry into the balustrade cavity	<p>The installation of brick capping demonstrates a failure to comply with approved plan titled “Detail Sections” which provides:</p>

Water could penetrate into the cavity of the balustrade wall, causing deterioration of building elements

8.	Balustrade walls on north facing balconies	Brick capping has been installed on top of balustrade walls.	<p>The Developer is to ensure the following building work is carried out:</p> <ol style="list-style-type: none"> 1. Balustrade walls are installed with metal capping in accordance with the regulated designs. <p>Alternatively:</p> <p>The Developer is to take the following specified action:</p> <ol style="list-style-type: none"> 1. Ensure the building practitioner obtains a variation to the regulated design and design compliance declaration for the building element prepared by a registered design practitioner. 2. Ensure the building practitioner or appropriate practitioner to lodge the regulated design and design compliance declaration on the NSW Planning Portal in the approved way prior to commencing building work. <p>The Developer is to ensure the following building work is carried out:</p>	1 month

1. Construct the balustrade walls per the approved plans and in accordance with the regulated design. 2. Rectify any consequential damage	
--	--	--	--	--
