Submission from the Australian Glass and Glazing Association for the NSW License review

27th August 2018
National Training Manager AGGA

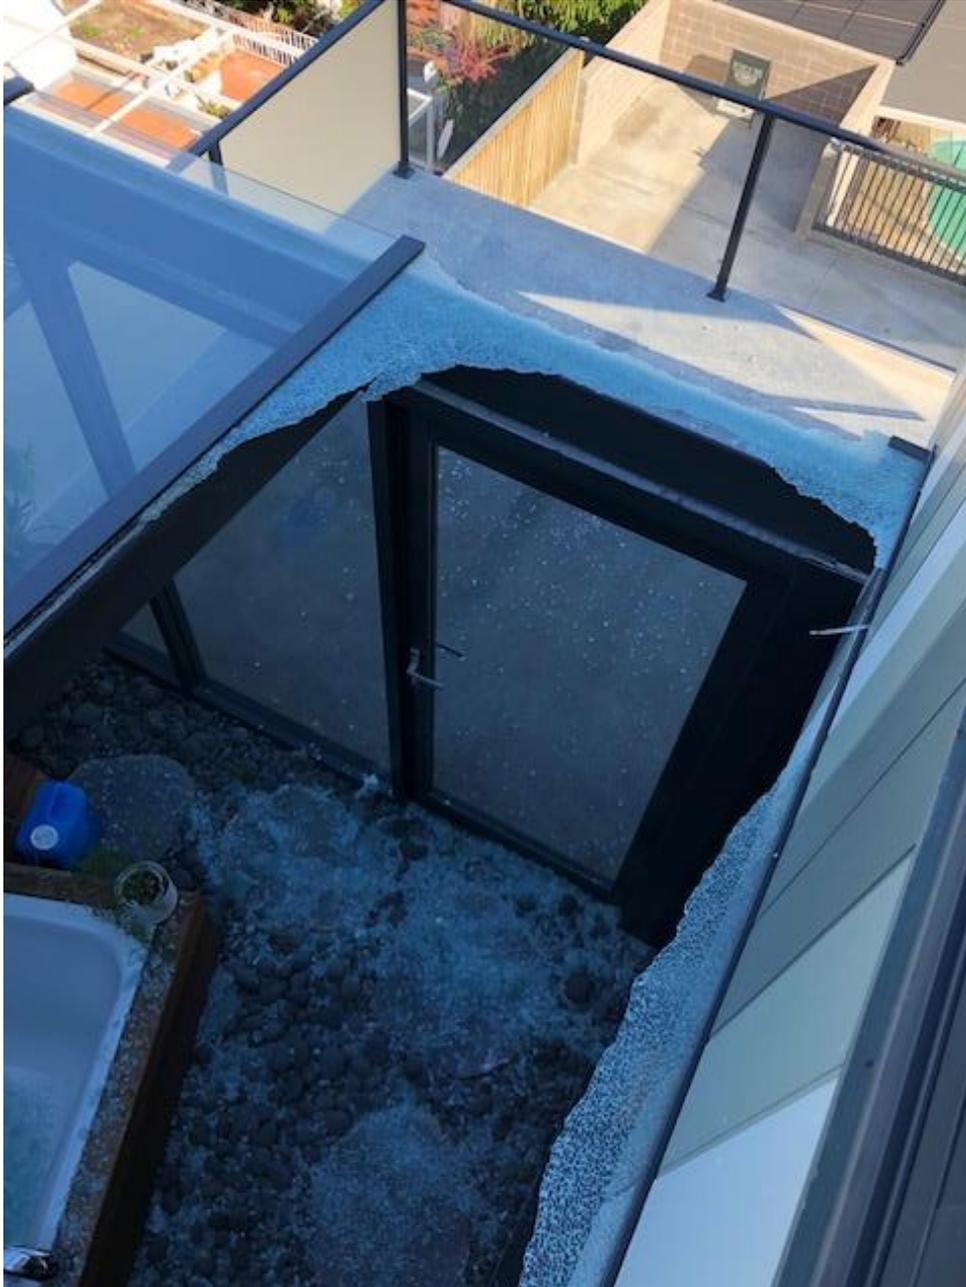
^{Note:} See the front page of this submission for a picture of a shattered panel.

The home owner approached an NSW AGGA member to replace overhead glass ceiling panel which has shattered. She had approached the builder, but they would take no ownership or responsibility. The house renovation is in Maroubra in Sydney.

The panels were purchased and installed by a builder who had no glazing experience, the installer used was not qualified a glazier nor did the builder consult with any qualified glaziers on this job.

The panels exploded when no one was in the room otherwise it could have resulted in major injuries. The consumer is now facing additional costs to replace the shattered panels.
